# ENGINE

## 1964 TEMPEST

### SYNCHRO-MESH TRANSMISSION COVERS

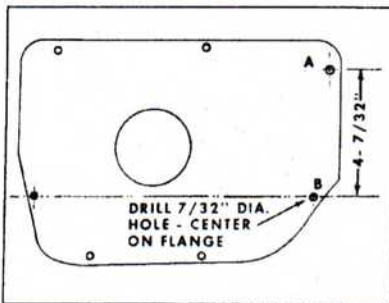
1964 Tempests built before October 7, 1963, with a 3 or 4 speed synchro-mesh transmission and console, or a 4 speed floor shift, used a screw at "A" Fig. 1 to attach the transmission shift control cover to the floor pan. See Fig. 7-11, 1964 Tempest Chassis Shop Manual. However, this rearmost screw is located directly over the propeller shaft and under certain conditions the shaft can hit the screw resulting in a damaged propeller shaft.

Therefore, all subject cars should be inspected for this condition and reworked at the earliest opportunity.

1. Remove those parts necessary to perform steps 2, 3 and 4.

2. Remove screw at "A" and fill hole with body sealer.

3. Drill a 7/32" diameter hole on the center of the flange at "B" Fig. 1.

4. Install screw and sealer at "B".
